SIO Shipyard Representative Bi-Weekly Progress Report		
Project: AGOR 28	Contract No.: N00014-12-C-0305	Shipyard: Dakota Creek Industries
Prepared by: Paul D. Bueren Scripps Institution of Oceanography (SIO) 297 Rosecrans St. San Diego, CA 98106	Date: January 16, 2015	Program Officer: Robert (Tim) Schnoor Office of Naval Research 875 Randolph St ONR 321 Arlington, VA 22203-1995
Distribution Statement A: Approved for public release; distribution unlimited.		Report No. A002.070

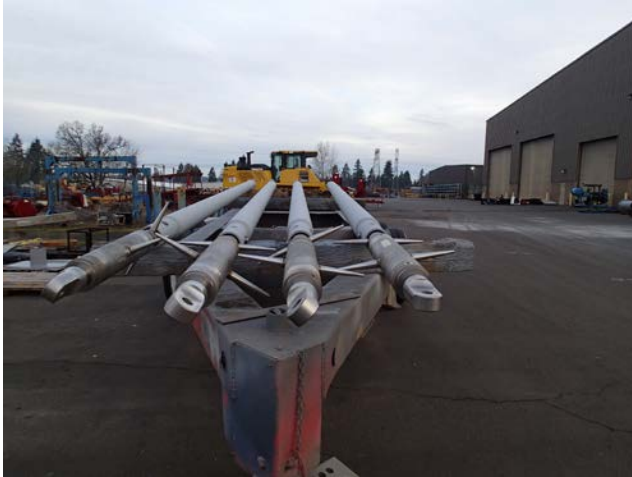
Two Set of Crutch Legs for both Armstrong and Ride

- Main Crane Towing & Coring Crutch – The crutch assembly being provided by Allied Systems needs to be demonstrated to prove that it can be used in a safe and practical way.

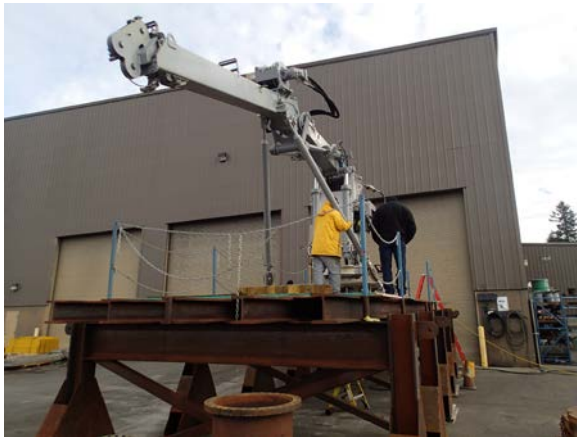
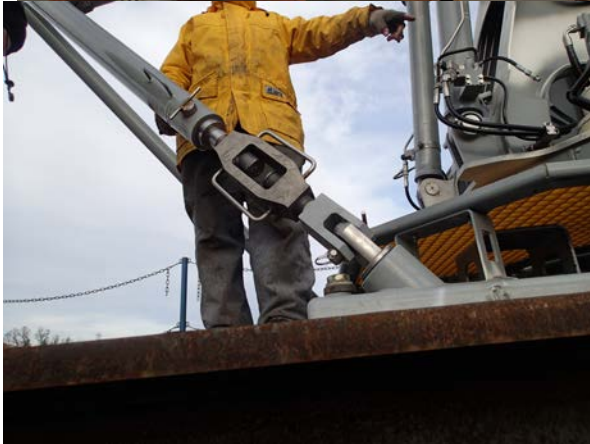
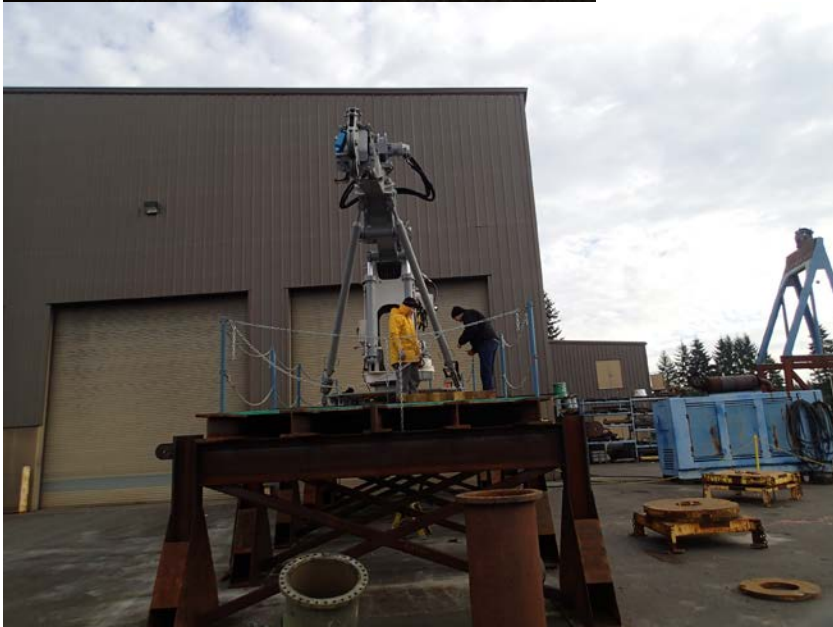
- Portable Crane Crutch – During the recent FAT, the portable crane crutch was deployed while the crane was mounted on the test bed. Three persons were able complete the deployment in about 15-minuts. As the crane is currently positioned on Armstrong, deployment of the crutch may be hindered by the bulwark.

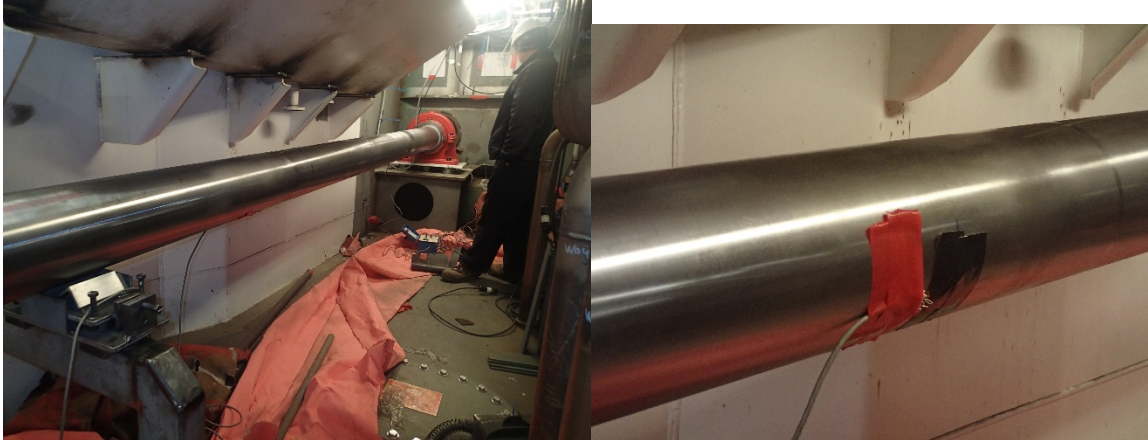
- Intermediate Shaft Bearings – Previously, LAMALO was on site to check the shaft loading on both vessels. For Ride, the starboard shaft was checked and found to be good. The port shaft was found to have a slightly elevated side loading after the initial check. The PCU was moved about 10/1000 to reduce this. As second check was made with shaft loading found to be good. For the test 6-each strain gauges were spot welded to the shaft; three between the stern tube seal and the PCU, and three between the PCU and propulsion motor coupling. Recently, LAMALO has provided a test report documenting the results for both of Rides shafts. The measured results were found to be within the expected range.

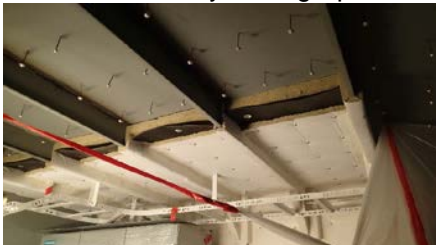
Mass Loaded Vinyl in Eng Space Overhead – Sally Ride

- Tuff-Mass MLV and Acoustic Tiles - Awaiting resolution of smoke and flammability issues. Acoustic Tiles have recently been laid in the Traction Winch Room on Armstrong despite ongoing reg body issues. These tiles are going to make housekeeping in this space difficult, but not impossible. On 16 December, DCI was notified by OCMI that further installation of MLV on Sally Ride is prohibited. 30% of the MLV has been installed on Ride at this time. Presently DCI is looking for an alternative solution or product to meet the specifications. No additional MLV has been added since this became an issue.

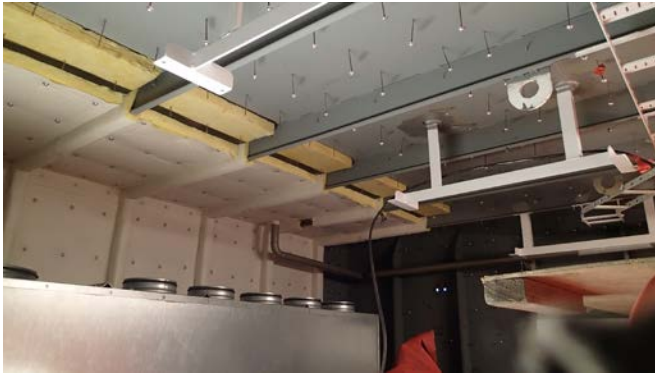
MLV HVAC Room Foc'sle Deck – Partial installation only in area where machinery has been placed. Most of the overhead and bulkheads have no treatment as yet. The fwd bulkhead has no insulation or sound treatment. The inboard bulkhead has only partial sound treatment.

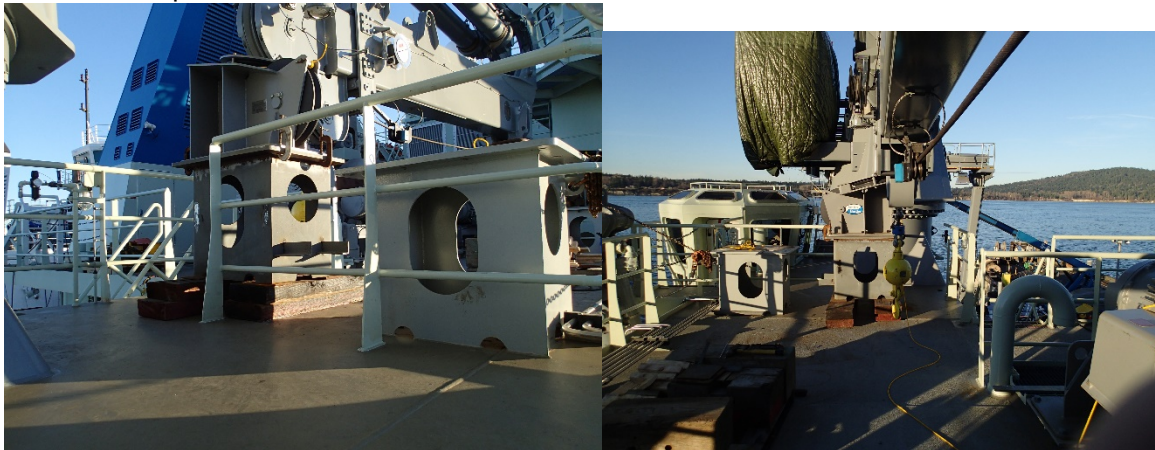
- Side & CTD Handling Systems – Unresolved issues with fairlead interferences from TK70-70 main crane remain. No changes since last reported. DCI is using Sally Ride's aft fairlead foundation to test various new locations on Armstrong. Ride's foundation was not permanently fixed so this is acceptable. The foundation was moved laterally to a position just inboard of the crane's boom and raised approximately 8-inches. This will allow the wire from the aft winch to pass aft of the cranes snout. It also appears that the forward winch will also be able to utilize this

change in configuration. No permanent changes should be made until both winches and handling devices are operational. For the fwd winch and CTD handling device, issues still remain in regards to possible interference with the crane's winch and crutch. These can best be verified once the winches and handling systems are operational. No movement on these issues since last report.

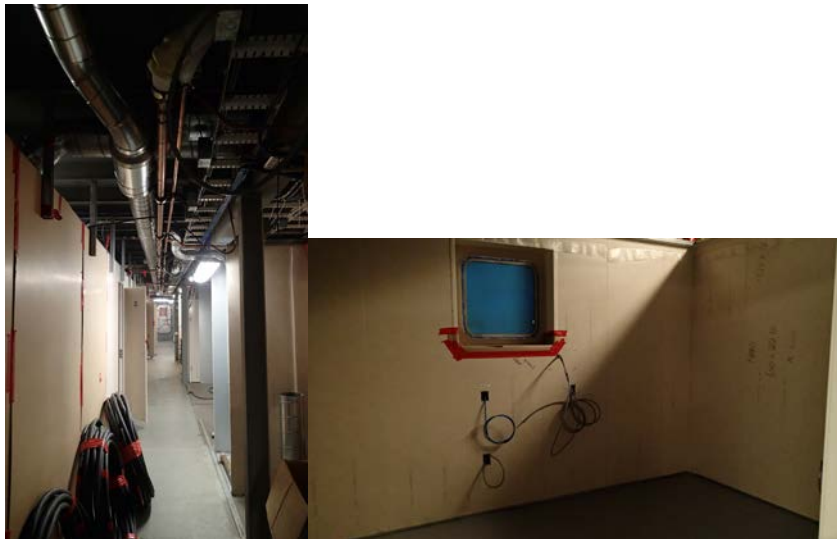
Foc'sle Deck

- Sally Ride Electrical – Work continues at a good pace. The yard is making connections to the 480-vac Switchboards, the Propulsion Drives and MCC's. Circuit panels and transformers are being located and connections are being made.
- Accommodation Spaces – A majority of the paneling and doors are in place on the Foc'sle deck. State room decks are primed and some ceiling hangers are going in. On the 01 Deck, panel installation is ongoing.

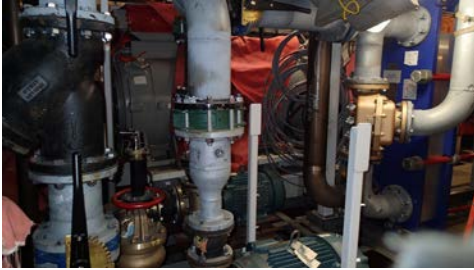
- Piping Systems – The FW Cooling system piping is nearing completion in the engine space. The hydraulic piping to the deck machinery has yet to be started.

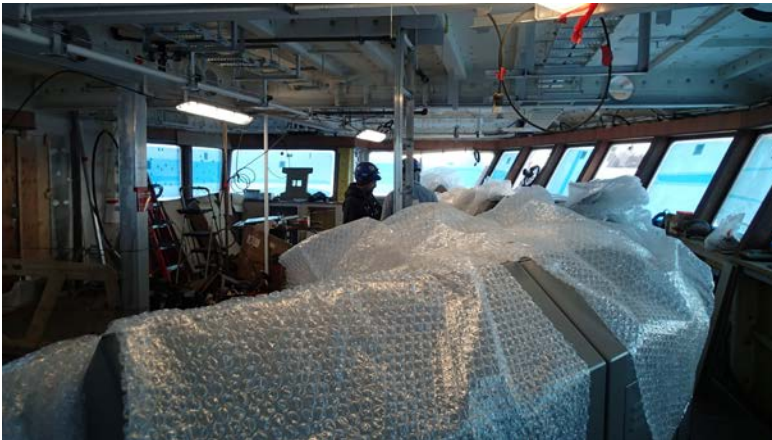
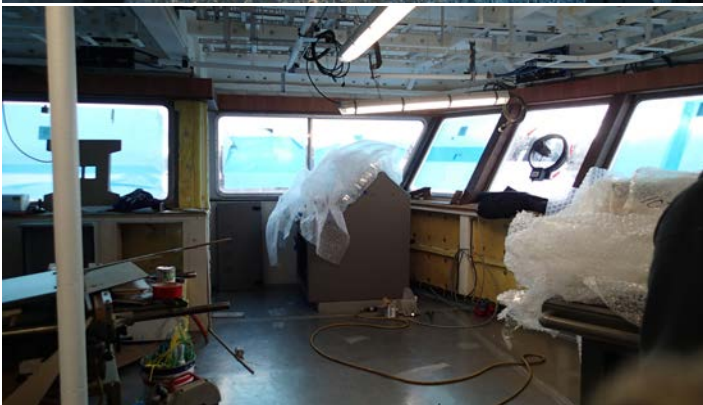
- Pilot House – Consoles have been placed in the space. Paneling and ducting has been staged for installation. Windshield wiper piping and cabling has been installed.

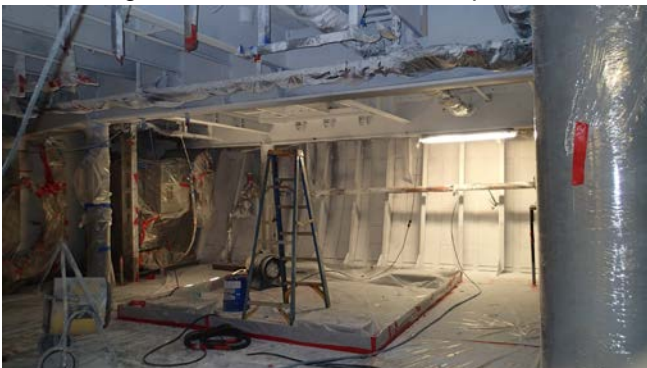
- Trawl Winch Space – Delta T is going on in preparation for eventual installation of the traction and stowage winches. Foundations are painted.
